Manhole Inspection Summary

Manhole # S06AA2014MH

Insp Date: **6/23/06 2:45 PM**

Location Address: **3911 FALLSTAFF RD**

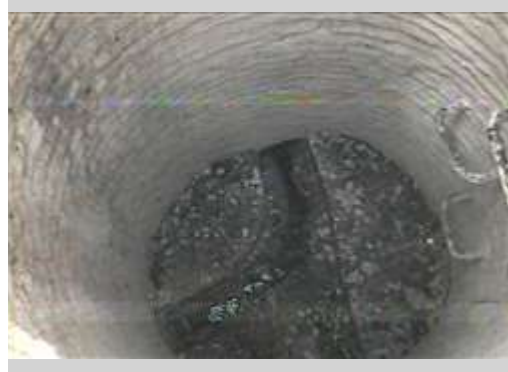
Top View

Adjustment infiltration. Corroded steps.
Evidence of surcharge - Bench debris.

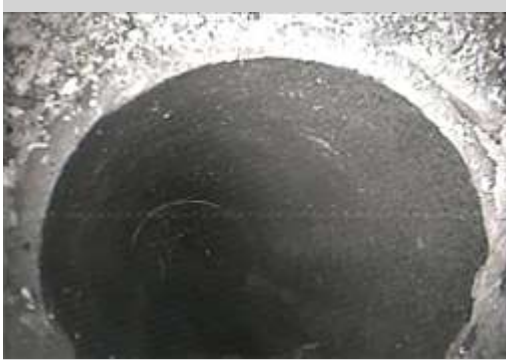
Inside of the O12

offset joint

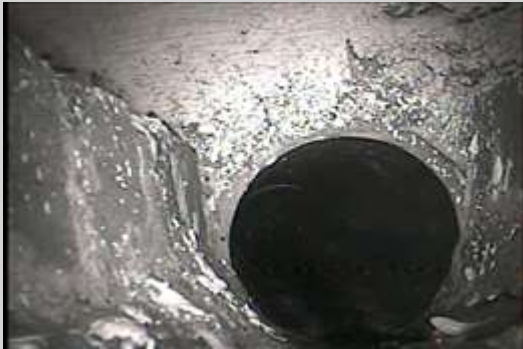
8 in. Circular Gravity Sewer Pipe Out @ 12 O'Clock

Infiltration: **Evidence** Pipe Seal Cond: **Cracked**
